## *Evaluating the Effectiveness of Window/Wall Interface Details to Manage Rainwater*

*Factsheet 3, February 2007*

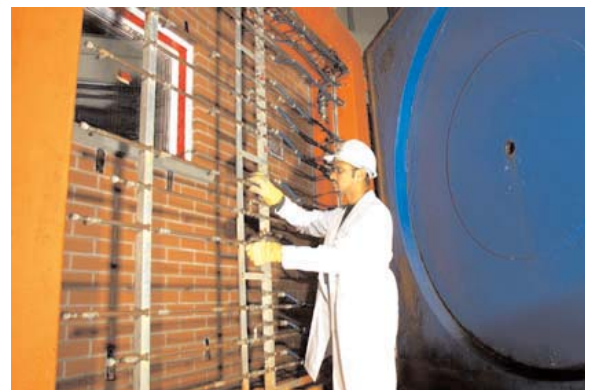
*Dynamic Wall Testing Facility*

We have developed a procedure to assess how well construction details mitigate the penetration of rainwater into a wall assembly. We are now assessing the water-management capabilities of specific construction details for selected combinations of window types and wall-cladding systems (e.g. vinyl, and hardboard), either installed according to standard methods or using variations of best practice. We have completed Phase I of this work, which focuses on evaluating window/wall details commonly used in Canadian practice.
